OBSERVATIONS ON SİNAN'S MOSQUES AND MASJIDS IN EYÜP

Assoc. Prof. Dr. Suphi SAATÇI

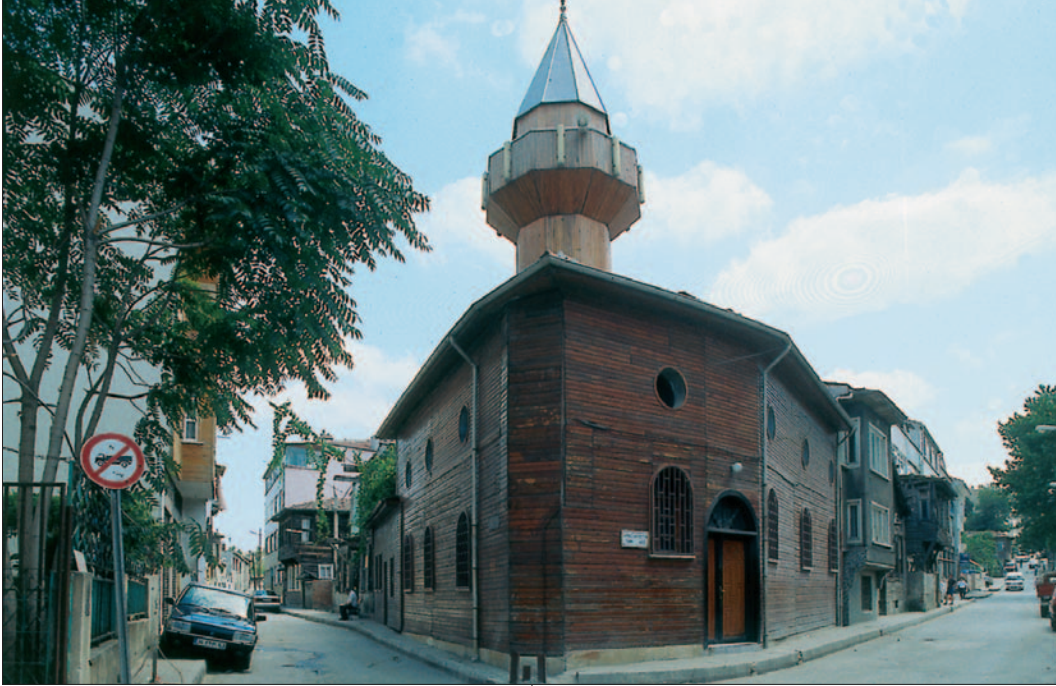
Illustration 1. Arpacıbaşı Masjid.
(Photo: Aras Neftçi)

Arpacıbaşı Masjid is in Akarçeşme, Eyüp. It was built by Arpacı Hayrettin. The time when it was built is not definitely known. The masjid, which has framed walls and a wooden roof, has an asymmetrical design. The present masjid, which exhibits a completely different design from its original one, was renovated in 1901 and again in 1986. Today, it does not reflect Sinan's style in any way. (Photograph 1)

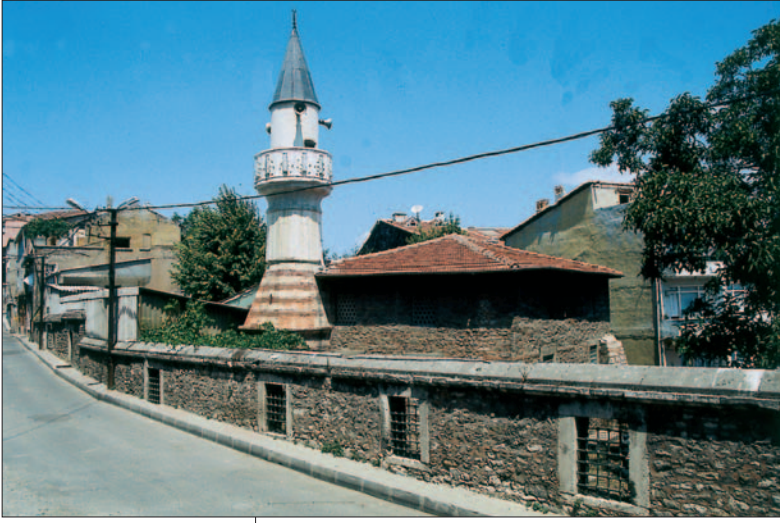
Illustration 2. Davut Ağa Masjid.
(Photo: Aras Neftçi)

Also known as Kapağası Masjid, this masjid is in Eyüp Nişancı. Davut Ağa, its founder, died in 1555 and is buried in front of its minaret. It is a small masjid which has a roof and a short minaret. Even though it has gone through a number of renovations, it has been preserved, relatively speaking. Some interior alterations were made, such as the addition of a room that is used as a library. Unfortunately, the use of inappropriate materials has damaged its original simple and naive outer appearance. The asphalt road which goes right along its side has been raised and the windows on its boundary wall have become level with the ground. It is

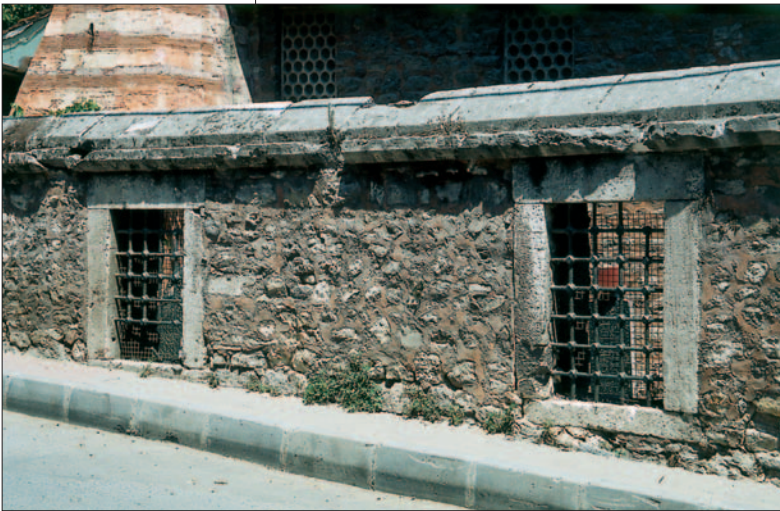
Illustration 3. Davut Ağa Masjid, damages done to the surrounding wall.
(Photo: Aras Neftçi)

apparent that occasional collisions of heavy vehicles with this wall have broken and shattered the wall and window jambs. Thus, certain precautions should be taken to save this masjid from further damage. (Photographs 2, 3 and 4)

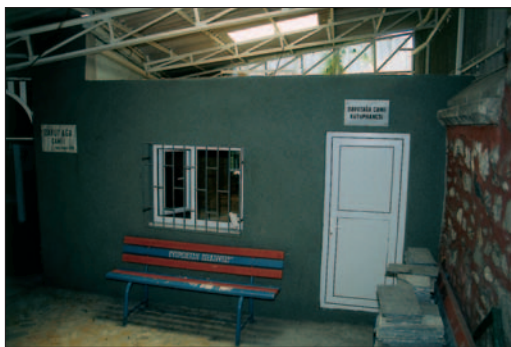
Illustration 4. Davut Ağa Masjid, the interior room added.
(Photo: Aras Neftçi)

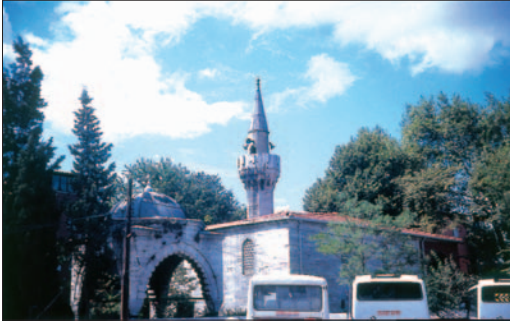
This mosque is in a district with the same name in Eyüp. According to its epitaph, it was built in 1540. The mosque, which has an almost square design, has a short minaret. The mosque has a roof built at an angle and its main walls are made of coarse cut-travertine. Obviously, its hipped-roof covered with tile has been restored. It underwent extensive renovations after the earthquakes in 1768 and 1895. It is known that Nazlı Mahmud Efendi, the founder of this mosque, was a calligrapher. Inside the enclosed graveyard in the grounds of the mosque, there is a canopy-shaped tomb facing south which has the features of Sinan's style similar to Ayas Pasha Tomb.

Illustration 5. Defterdar (Nazlı Mahmud Efendi) Mosque.

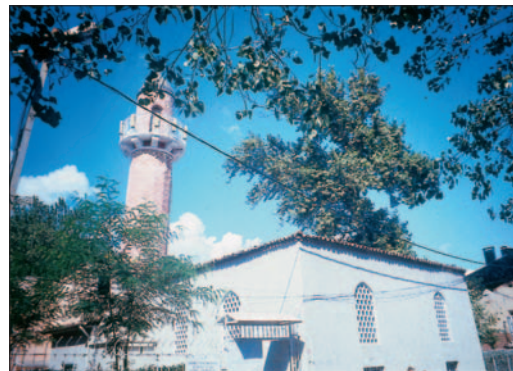
There is a crack on the kible wall of the mosque starting from the arched-window farthest to the left of the top series of windows and gets deeper along its path towards the window below. This may be serious and should be taken care of. (Photographs 5 and 6)

Illustration 6. Defterdar Mosque, the crack on the Kible wall.

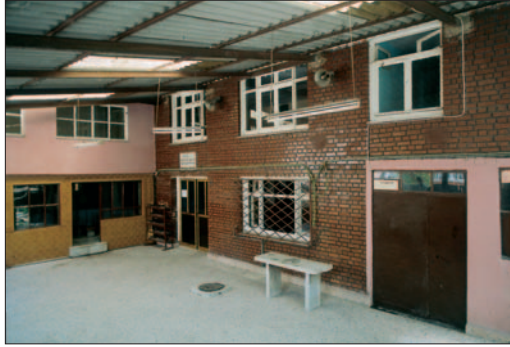
Illustration 8. Nişancı Mustafa Pasha Masjid, last assembly hall.
(Photo: Aras Neftçi)

It was observed that the front wall, where the main door of the present mosque is located, has been erected with inappropriately painted bricks, and supposedly a last assembly room has been created which seems to have been covered with inferior quality materials. Apart from these, the ritual ablution area and the toilets have not been properly constructed either.

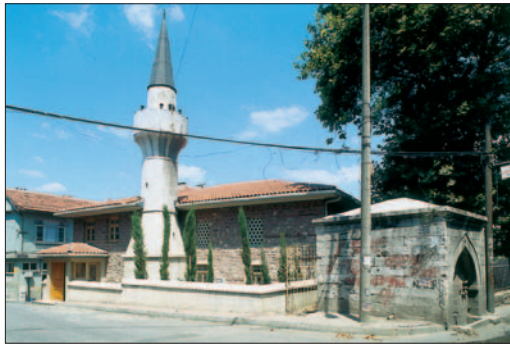
Illustration 9. Süleyman Subaşı Masjid.
(Photo: Aras Neftçi)

This masjid is known as *Müzevvir* (mischief-maker), *Münzevi* (hermit) and *Karcı* (snow-seller) Süleyman Masjid. The most interesting feature of the mosque, whose date is unknown, is its dwarf minaret. Its design is nearly square, has a roof and the walls are made of rubble stone. The most recent renovation of the masjid must have been an exaggerated attempt to decorate it. As a result, the restoration of the main door in the front and the new structure fused to the back of the mosque have damaged its traditional features.

The masjid has no courtyard (enclosed graveyard), but there is a fountain that bears no inscription and is located on the street, in the direction to kible. The most interesting aspect of the fountain is its possession of a small spring. Due to continual elevation of the road, the drinking basin of the fountain is now almost buried in the ground. The fountain also has a dirty appearance because it is continuously splattered by dust and soil as vehicles pass on this road that has no sidewalk. (Photograph 9)

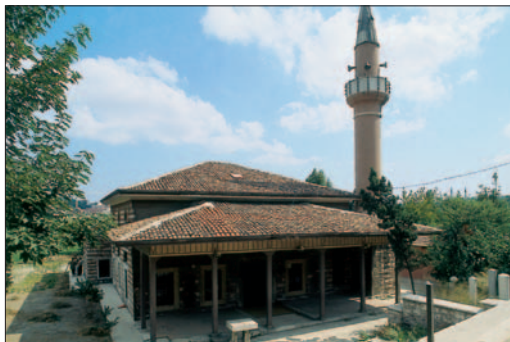
Illustration 10. Shah Sultan Mosque.
(Photo: Aras Neftçi)

This mosque is on Silahtarağa Street in the Bahariye district of Eyüp. According to its epitaph, it was built by the daughter of Yavuz Sultan Selim in 1556. The mosque is rectangular in width and has a roof. It has stone-brick main walls and a tiled roof. The last assembly area in the front has wide eaves and wood columns. The main walls and the pulpit of the minaret date to the 16th century. The minaret itself is believed to belong to the 18th century. It is understood that the wood columns were erected in 1971. The mosque was demolished in the 1766 earthquake and was reconstructed during the time of Mustafa III. Since the decision to remove the buildings along the Golden Horn, it has been

standing alone, all by itself. As a result, its assembly has been greatly reduced and it has lost its liveliness due to decreased interest of the people. (Photograph 10)

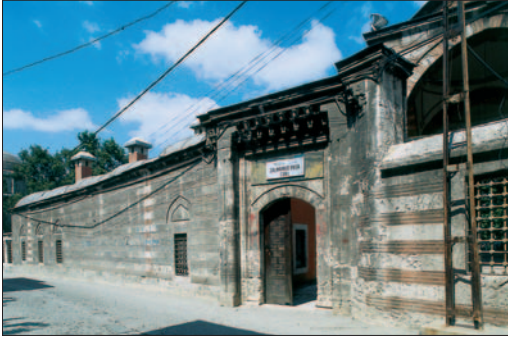
In spite of its great significance, the *külliye*, as a whole, has been deprived of the care it deserves. Particularly, the western walls of its grounds have become very dirty, due to speeding vehicles on the road which goes along these walls. Undoubtedly, closing this road, which is narrow and has no sidewalk, would also be desirable to save these structures from imminent damages that would arise from ground vibrations caused by the fast moving traffic. It was also observed that the stone railings in the last assembly hall and in the upper medresseh were broken in parts. The first step to be taken should be to repair these before any further damage. It should also be noted that both the madrasa and the other structures in the *külliye*

Illustration 11. Zal Mahmud Pasha Mosque, the condition of the west wall of the *külliye* suffering from traffic. (Photo: Aras Neftçi)

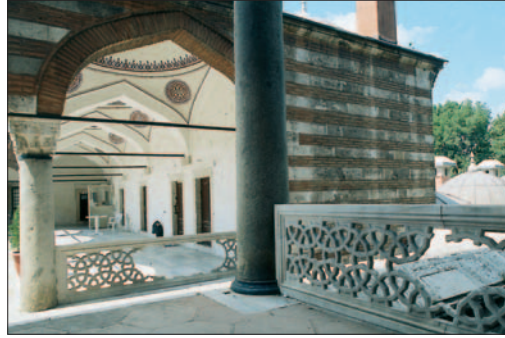
Illustration 12. Zal Mahmud Pasha Mosque, the condition of railings in the last assembly room and the upper madrasa. (Photo: Aras Neftçi)

deserve a much closer attention and that they should be handled with more care. (Photographs 11 and 12)
